DOCUMENT TYPE: Service Bulletin **NAME:** SB-GOAT-20220525 – Solder Sleeve & Wiring Issue

APPLICABILITY: All Goats equipped with a Gen1 Wire Harness

ISSUE REPORTED: Solder Sleeve melt-able ring remains “unmelted” & therefore leaves wiring circuit either ungrounded or lacks connectivity for purpose.

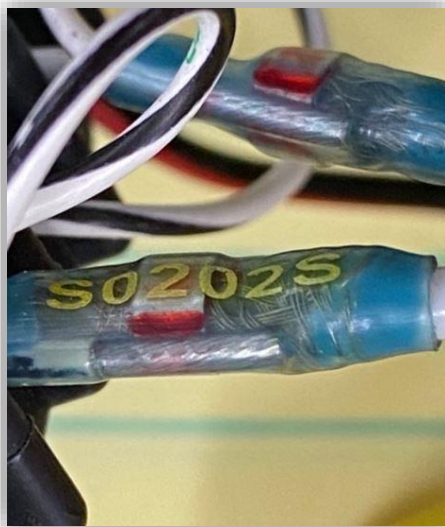
FACTORY FINDINGS & COMMENTS: (Photos Available Below) Based on the exhibits submitted, we can only surmise that the Solder Sleeve(s) was/were heated to the point that the plastic portion & sealant of the Solder Sleeve was melted - but the actual ring of melt-able solder did not. The solder sleeve must melt completely to fuse the wires & achieve connectivity. Proper grounding of the electrical system is necessary to shut the engine OFF – or render it unstartable. This is especially important when the prop is rotated for maintenance or for purging the oil circuit prior to starting engine after a period of nonuse.

PHOTO 1: This is the issue found in the field. You can see that while the Plastic Sleeves and Sealant at ends of the Sleeves appear melted, the Melt-able Solder Rings are NOT "melted" to create connectivity for purpose. To be clear, these Solder Sleeves in the photo are not correct. No "Red" should be visible.

Inspection Description: At a minimum, inspect all Solder Sleeves for complete melting of the Solder Ring. They can be, but not always, used on the following systems:

Service/Replacement Description: We suggest using an Avionics Technician because they will know exactly what they're looking for & how to separate the wires enough to inspect, heat & confirm melting / connectivity for purpose. See photos below for familiarity.

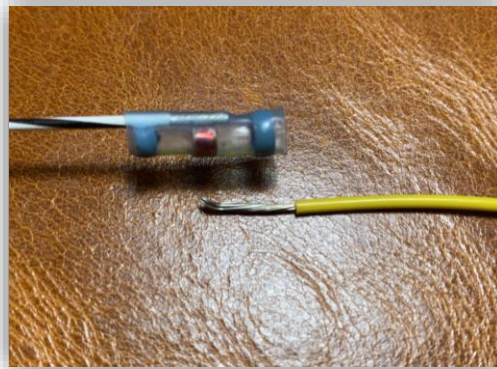
PHOTO 2: Solder Sleeve ready to attach Prepped Wire - Solder Sleeve (Left) / Prepped Wire (Right)

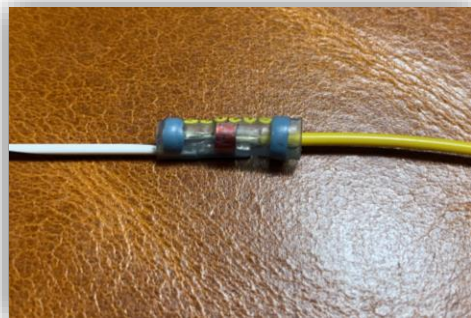
PHOTO 3: Prepped Wire Inserted into Solder Sleeve

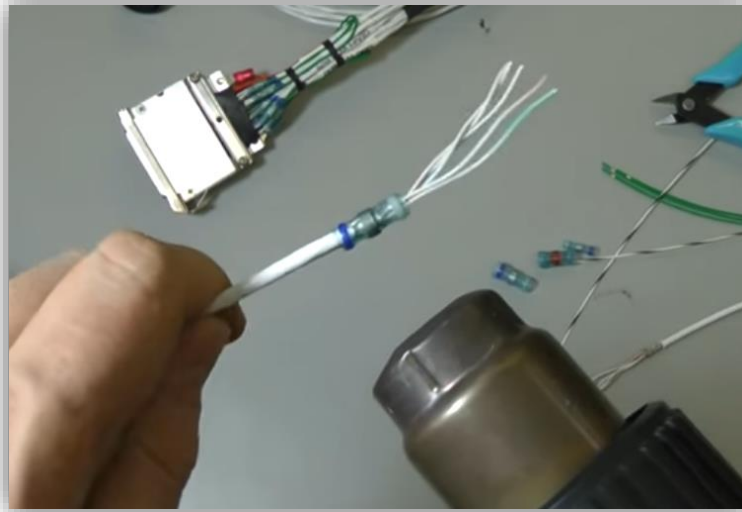
PHOTO 4: Solder Sleeve being heated to point where Meltable Ring must melt.

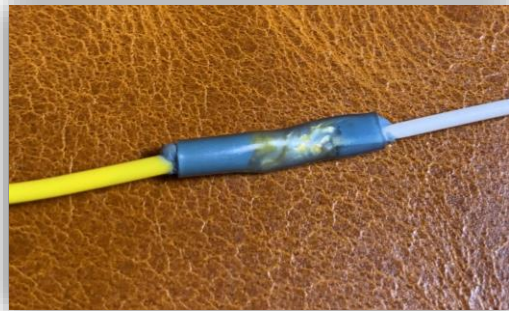
PHOTO 5: Solder Sleeve with Meltable Ring now “melted”. Clearly, the “ring” visible as a shade of red in the prior photos has liquified & become the solder/binder creating connectivity between the 2 wires. The red dye is no longer visible.
