DOCUMENT TYPE: Service Bulletin **NAME:** SB-GOAT-20220525 – Solder Sleeve & Wiring Issue

APPLICABILITY: All Goats equipped with a Gen1 Wire Harness

ISSUE REPORTED: Solder Sleeve melt-able ring remains “unmelted” & therefore leaves wiring circuit either ungrounded or lacks connectivity for purpose.

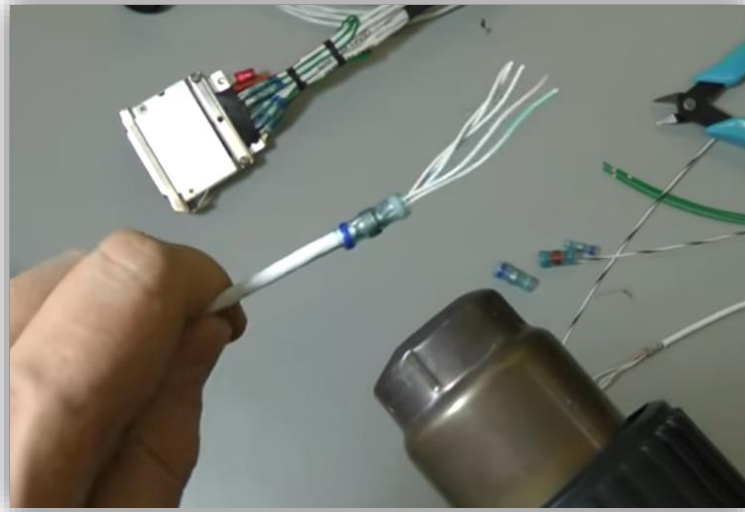
FACTORY FINDINGS & COMMENTS: (Photos Available Below) Based on the exhibits submitted, we can only surmise that the Solder Sleeve(s) was/were heated to the point that the plastic portion & sealant of the Solder Sleeve was melted - but the actual ring of melt-able solder did not. The solder sleeve must melt completely to fuse the wires & achieve connectivity. Proper grounding of the electrical system is necessary to shut the engine OFF – or render it unstartable. This is especially important when the prop is rotated for maintenance or for purging the oil circuit prior to starting engine after a period of nonuse.

PHOTO 1: This is the issue found in the field. You can see that while the Plastic Sleeves and Sealant at ends of the Sleeves appear melted, the Melt-able Solder Rings are NOT "melted" to create connectivity for purpose. To be clear, these Solder Sleeves in the photo are not correct. No "Red" should be visible.

Service/Replacement Description: We suggest using an Avionics Technician because they will know exactly what they're looking for & how to separate the wires enough to inspect, heat & confirm melting / connectivity for purpose. See photos below for familiarity.
